IP Office Technical Bulletin

Bulletin No: 173
Release Date: 01 December 2014
Region: Global

General Availability (GA) - IP Office Release 9.0 Service Pack 5

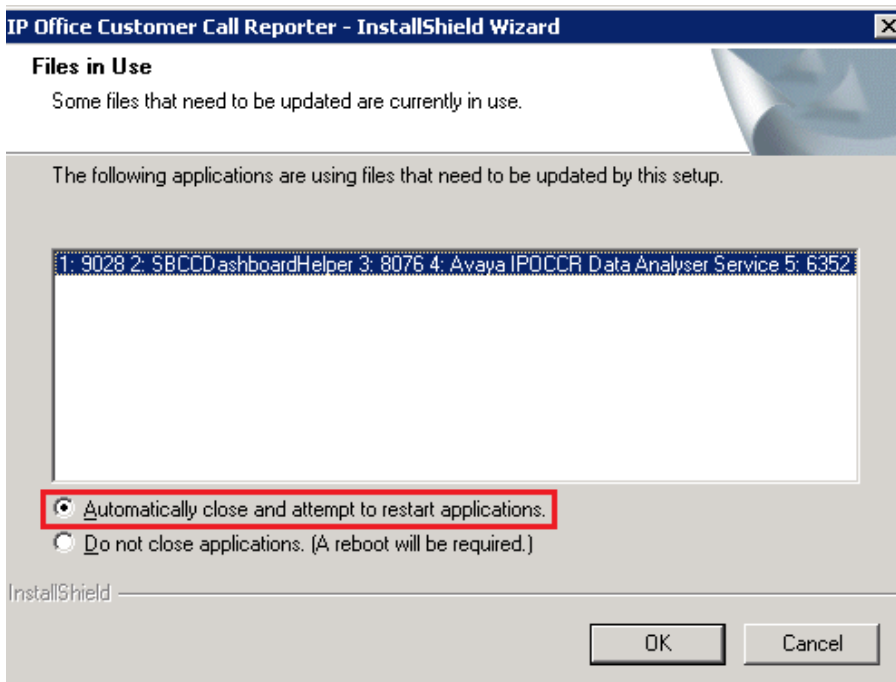
The following dialog box may be displayed during an upgrade to this release:

If this is displayed during the upgrade ensure that the highlighted option is selected and then click “OK”. The upgrade will then continue as normal.
